Final -- June 29, 1987

Preliminary Assessment
Redwood Road Dump
Salt Lake City, Utah
UTD980961502

Prepared For
Utah State Department of Health
Bureau of Solid and Hazardous Waste

by Michael C. Long

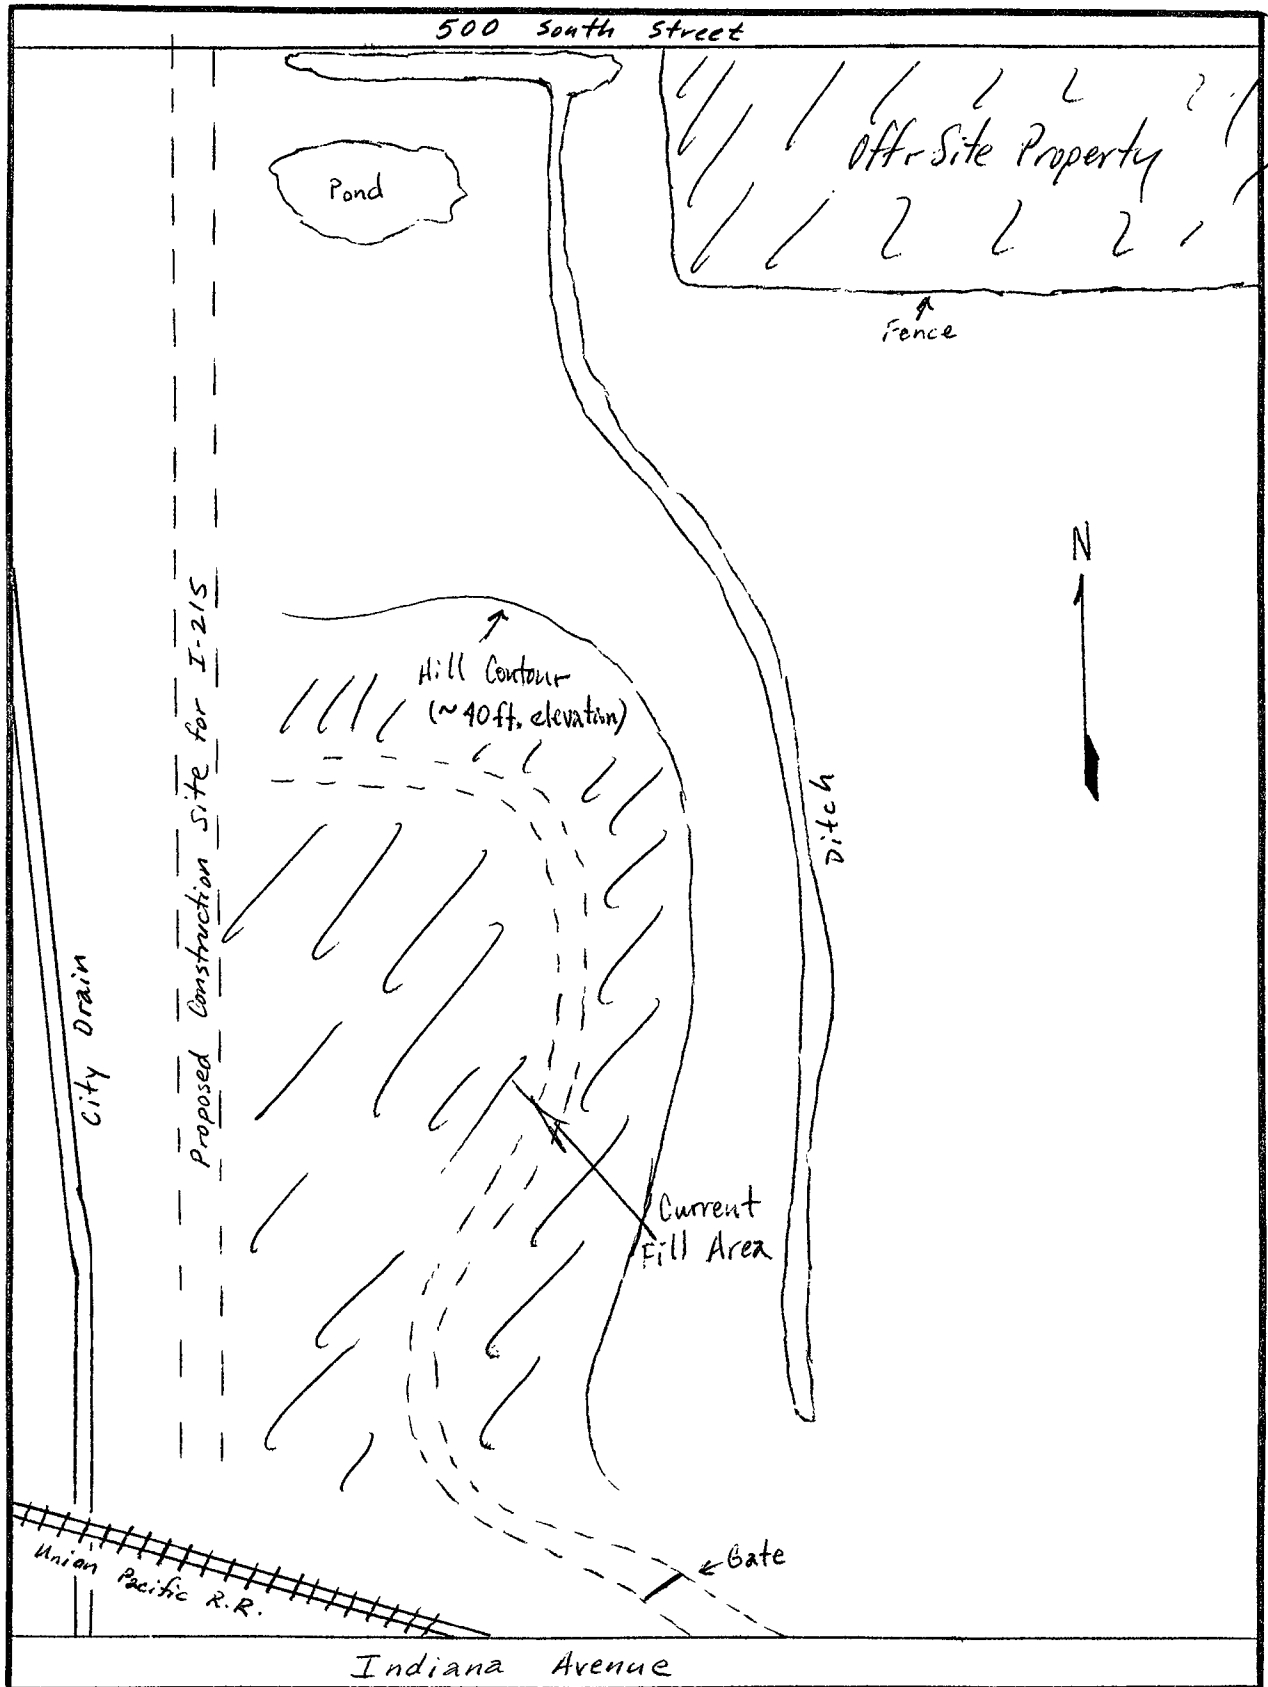
Figure 3 - Site Sketch
(Not to scale)

In addition to City Drain, a ditch runs north and south across the center of the site (no outlets), and a small pond (possibly recharged by ground water) is located in the north end of the site (see Figure 3 - Site Sketch). Again, there are no known domestic uses of this water, but local fauna use it for drinking.
