SITE RE-ASSESSMENT (SRA) REPORT

Redwood Road Dump
Salt Lake County, Utah
UTD980961502

Prepared by: Neil Taylor
Utah Department of Environmental Quality
Division of Environmental Response and Remediation

SITE VISIT REPORT
For the Redwood Road Dump
CERCLIS ID UTD980961502

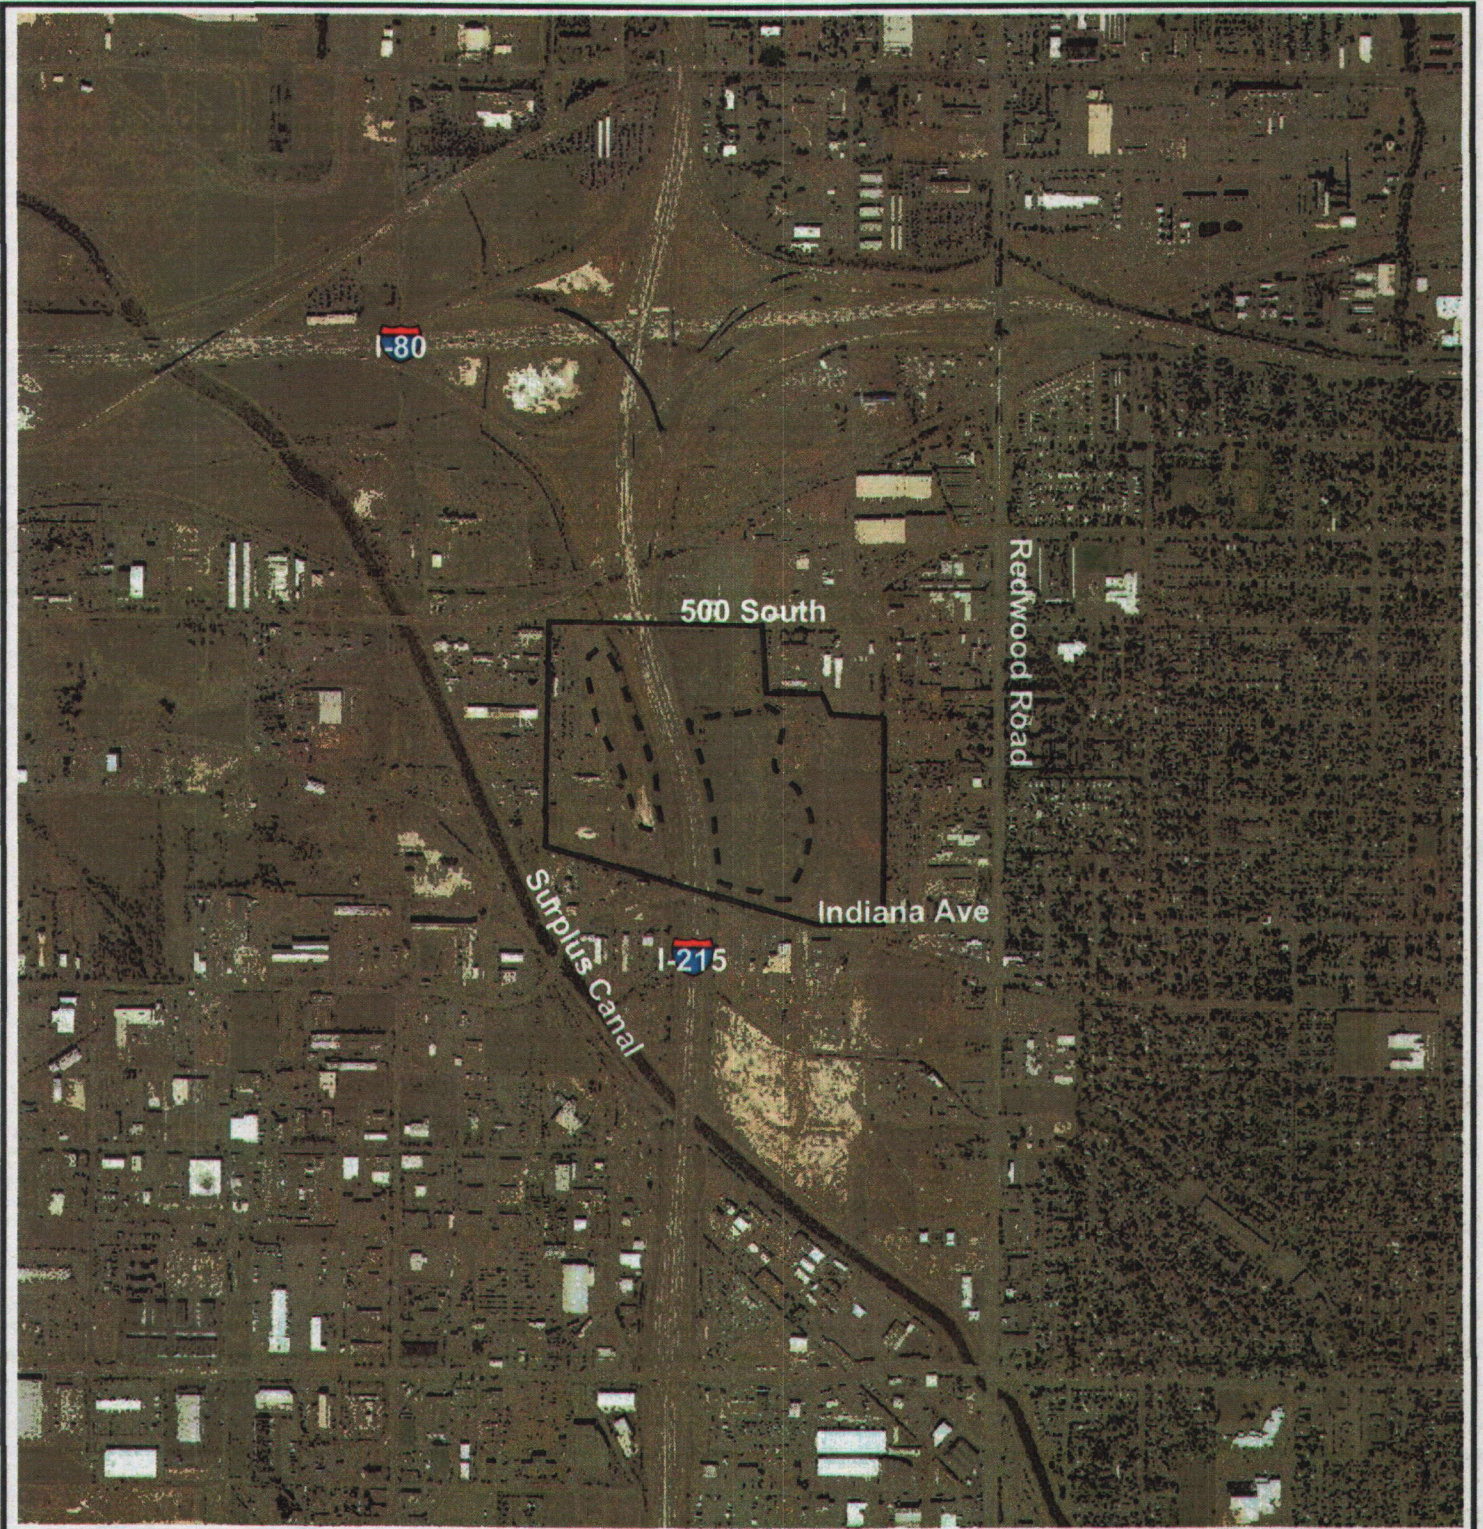
Figure 1
Site Location Map
Redwood Road Dump Site
Salt Lake County, Utah

The Site extends west from 1900 West Street to 2200 West Street, and south from 500 South Street to Indiana Avenue (800 South) in Salt Lake City, Utah (Figure 1). The Site is approximately 70 acres in size and is owned by Salt Lake City Corporation (DERR, 1995). The Site is located in the SE 1/4 of the SE 1/4 of the NE 1/4 of Section 9, Township 1 South, Range 1 West, Salt Lake Base Meridian (USGS, 1962). The Site is bisected by Interstate 215 (I-215) and includes an eastern and western refuse pile. The Salt Lake City Road Maintenance and Automobile Impound Lot is located directly north (across 500 South Street) of the western portion of the Site.

-   Site Boundary
-   Landfills

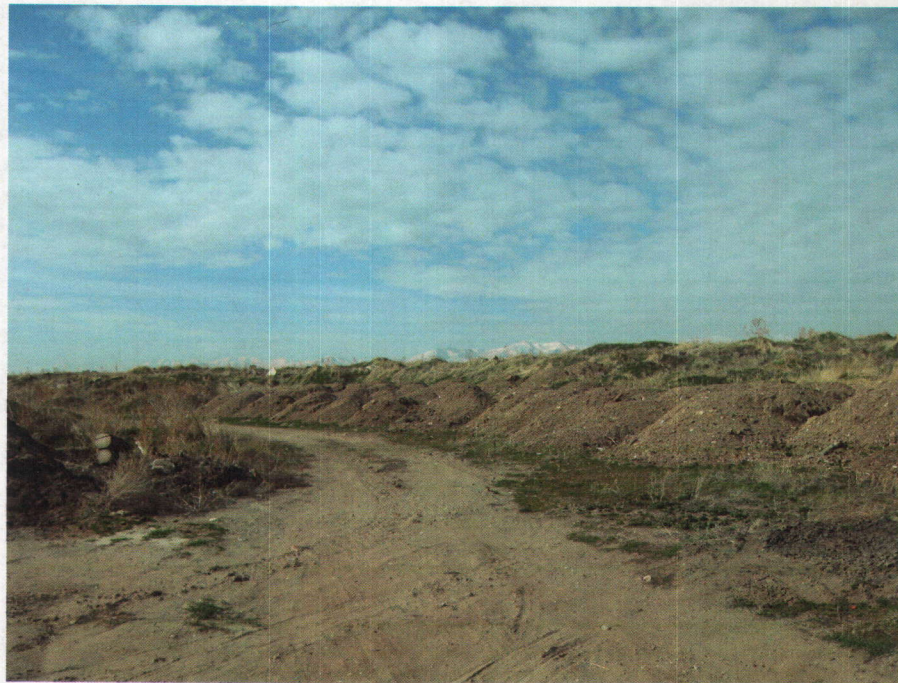
Figure 1

Looking southwest on site access road, east of the eastern landfill. Soil piles are from city cemetery. Elevated area in the background is the eastern landfill.

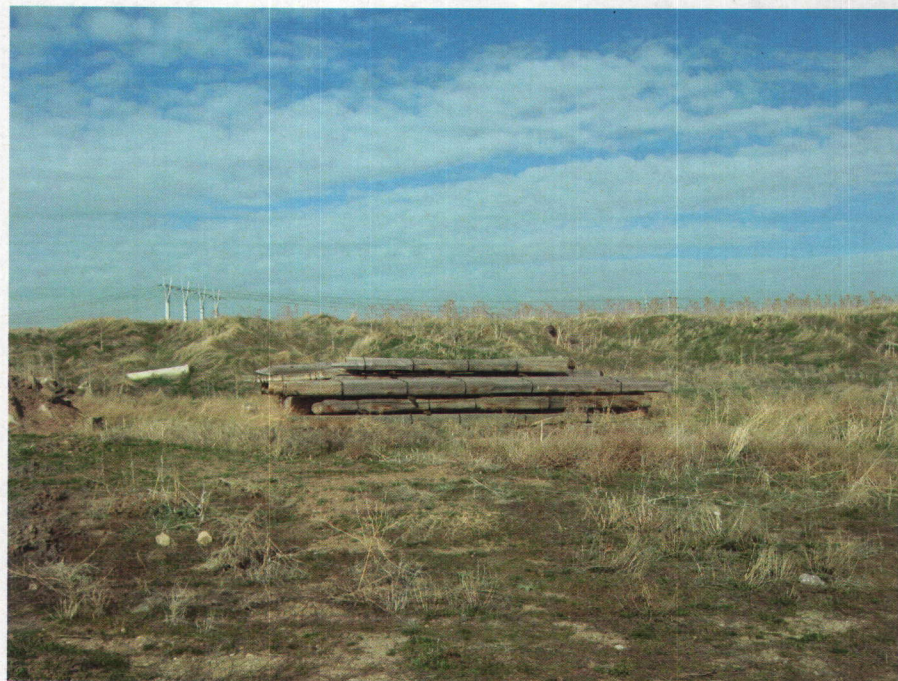
Figure 2

Stored logs in front of raised edge of eastern landfill.

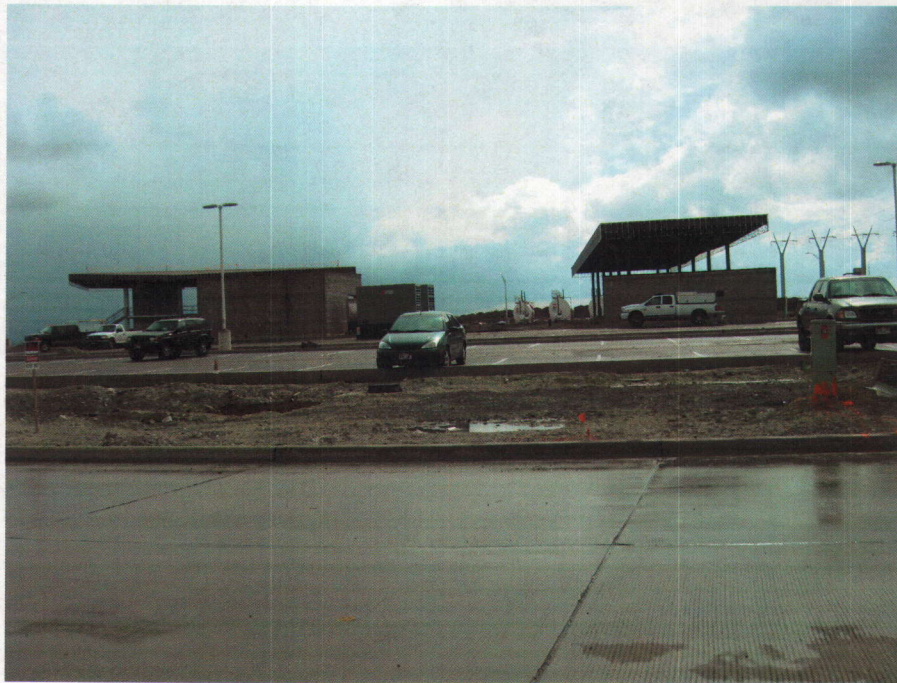
Figure 3

City vehicle washing and fueling facility under construction north of the eastern landfill (looking south).

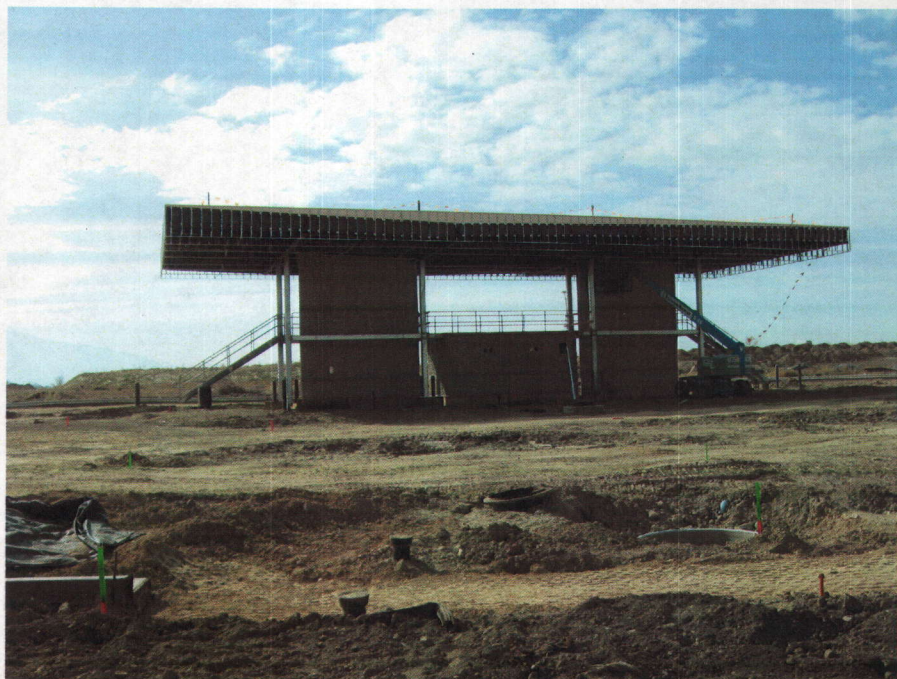
Figure 4

Large truck washing facility north of the eastern landfill. Elevated area in the background is the eastern landfill (looking south).

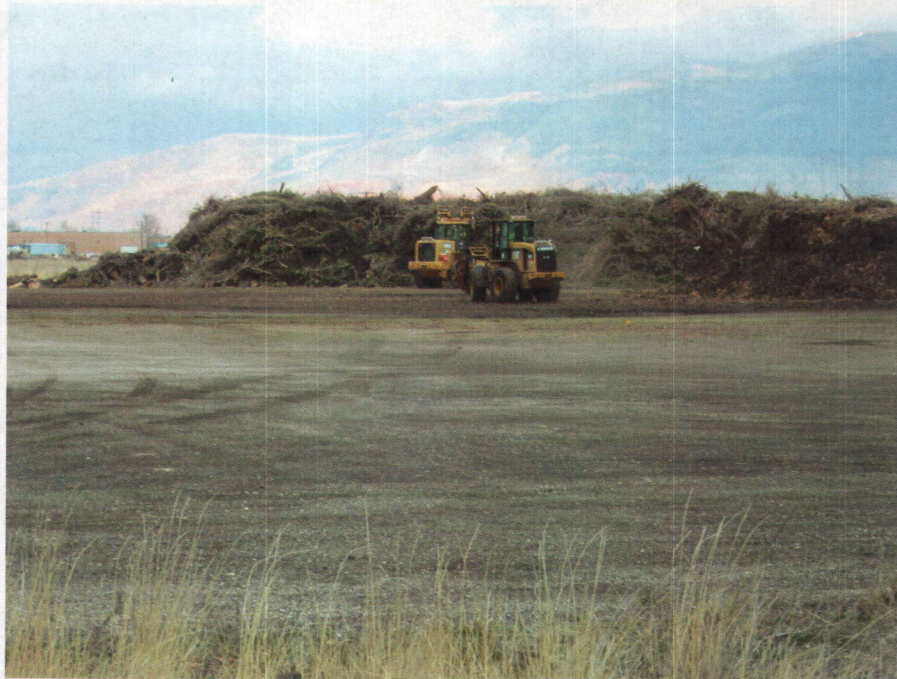
Figure 5

An asphalted area located southeast of the eastern landfill and used for storage of chipped trees, limbs and leaves (looking northeast).

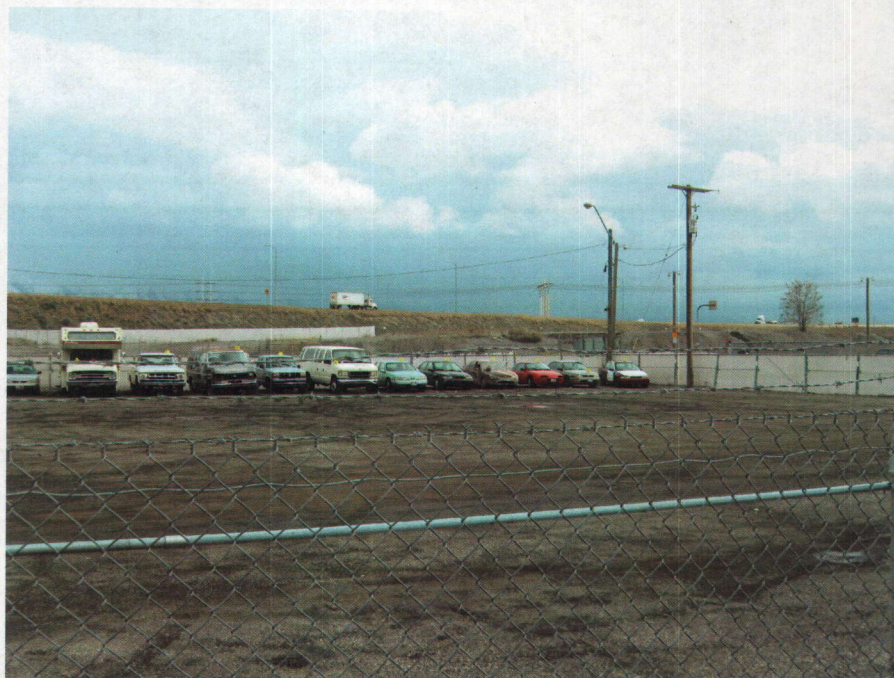
Figure 6

Northern end of the western landfill located next to I-215 and east of the city impound lot in the foreground (looking southeast).

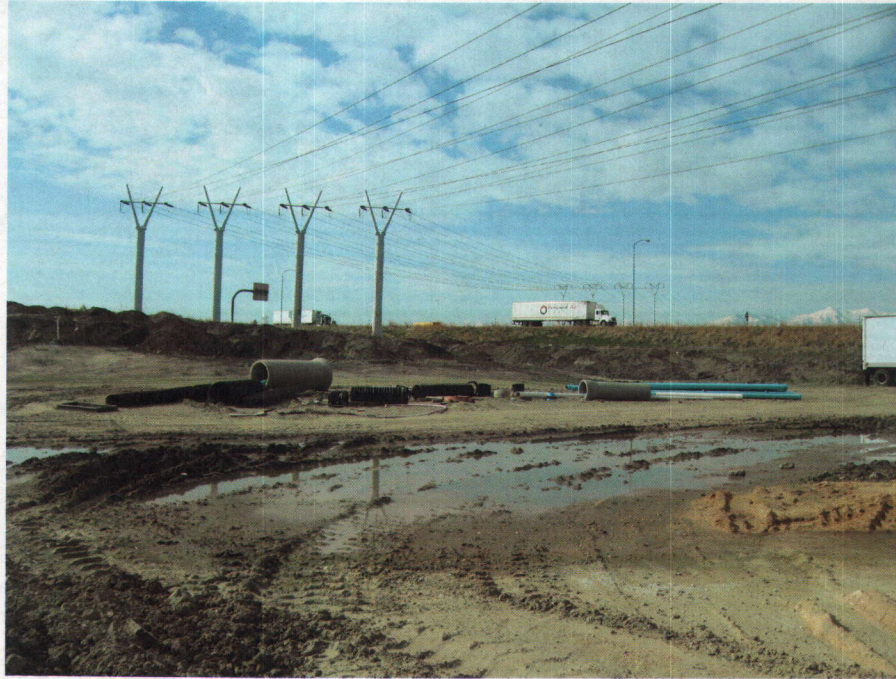
Figure 7

Looking east at the high-voltage power poles installed through the top of the western landfill. Observation point is from the city's storage yard located directly west of the western landfill.

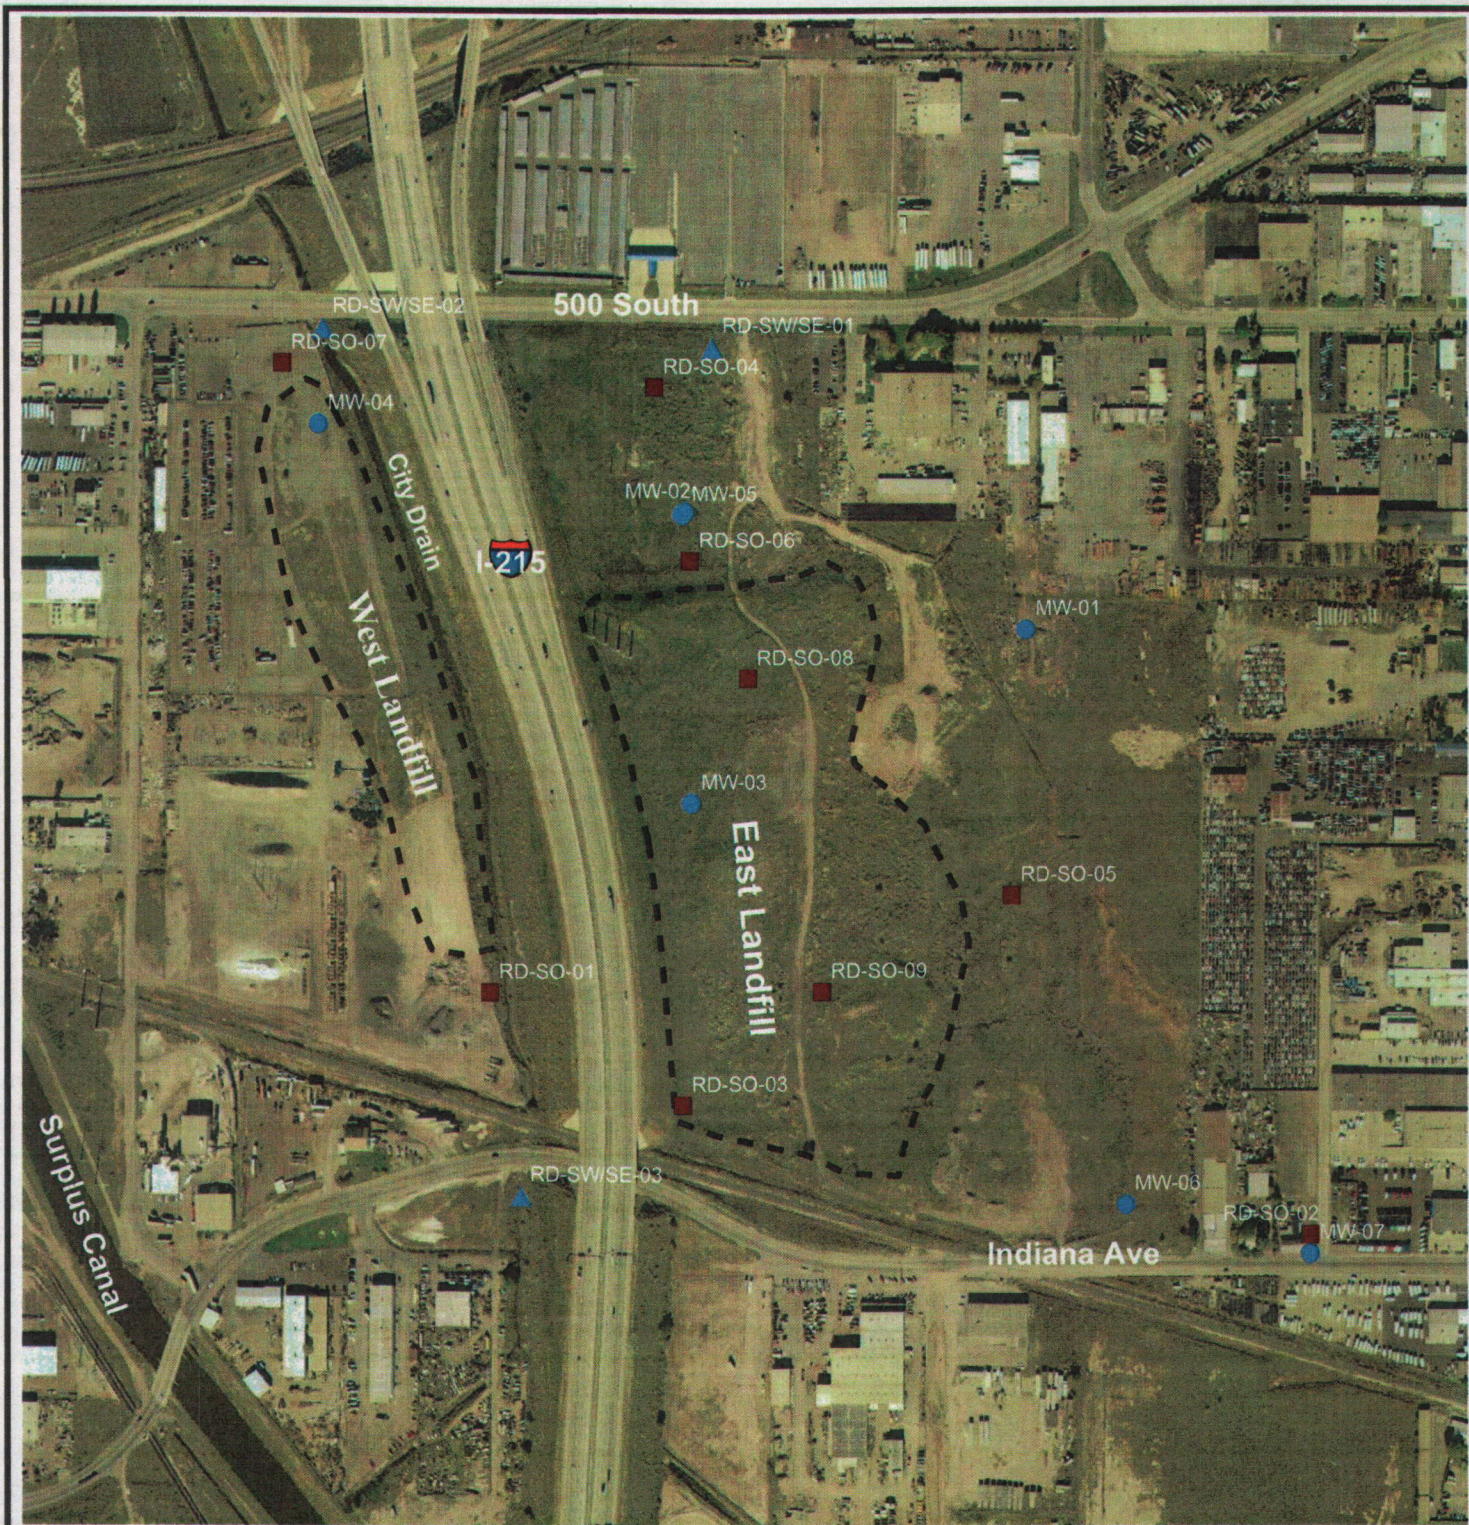
- Monitor Well Location
- x Sample Location

UTAH DEPARTMENT OF HEALTH BUREAU OF ENVIRONMENTAL RESPONSE AND REMEDIATION		
Sample Location Map Redwood Road Dump Site Figure 5		
By TH	Date 6/11/91	Scale Not to Scale

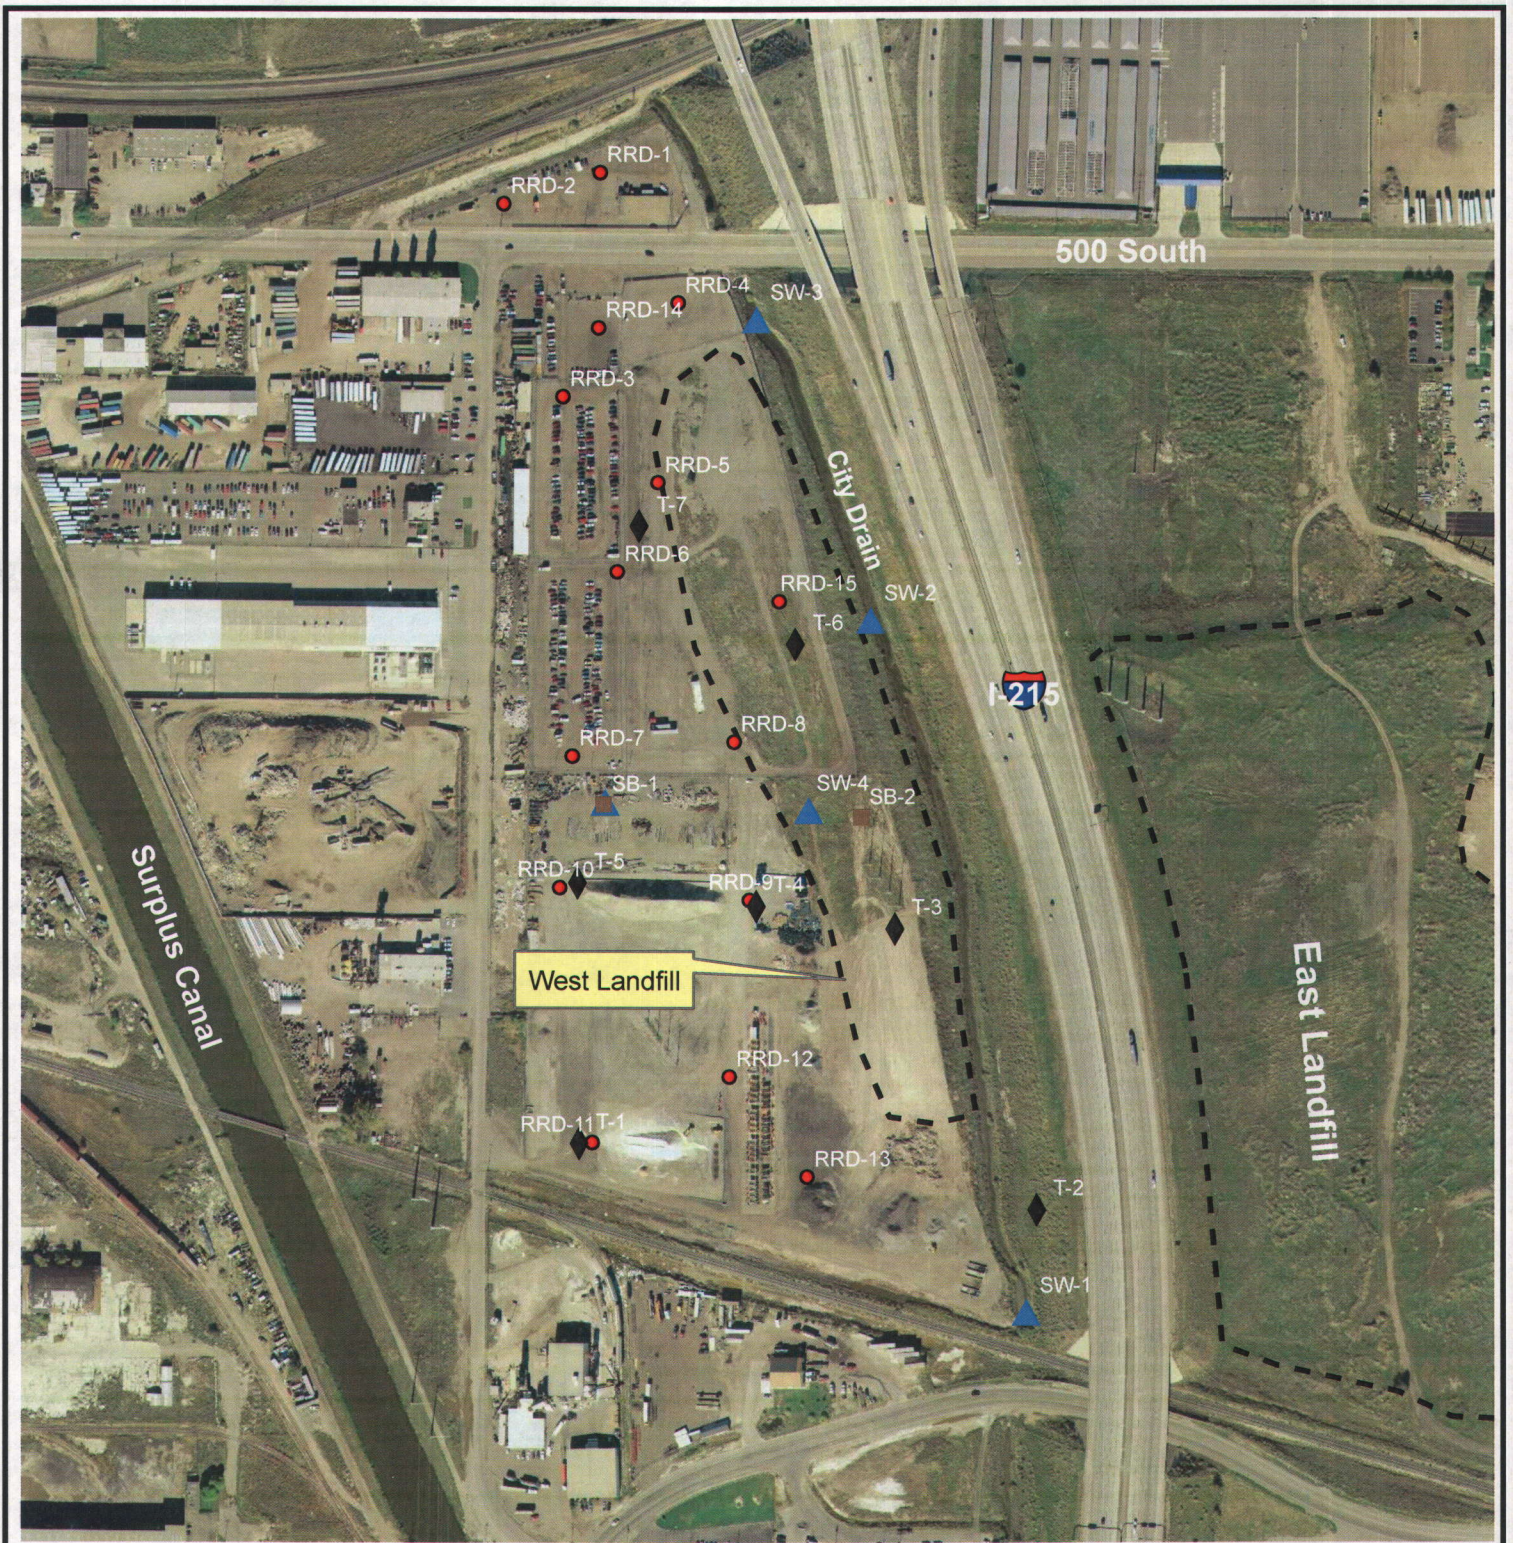
Figure 1
Approx. Sample Location Map
Redwood Road Dump
2001 TBA, 2008 Photo
Salt Lake County, Utah

Soil samples were collected during installation of the direct push groundwater samples and from selected trench locations across the Site. Soil samples were collected directly at the soil/water interface. Most soil samples were collected between seven to nine feet below ground surface. Soil sample locations are provided as Appendix D, Figure 1 and provide 2008 satellite imagery for the sample locations.
