SITE INSPECTION PRIORITIZATION

**REDWOOD ROAD DUMP SITE**

Salt Lake County, Utah  
UTD980961502

Utah Department of Environmental Quality  
Division of Environmental Response and Remediation  
Prepared By: Elizabeth A. Yeomans

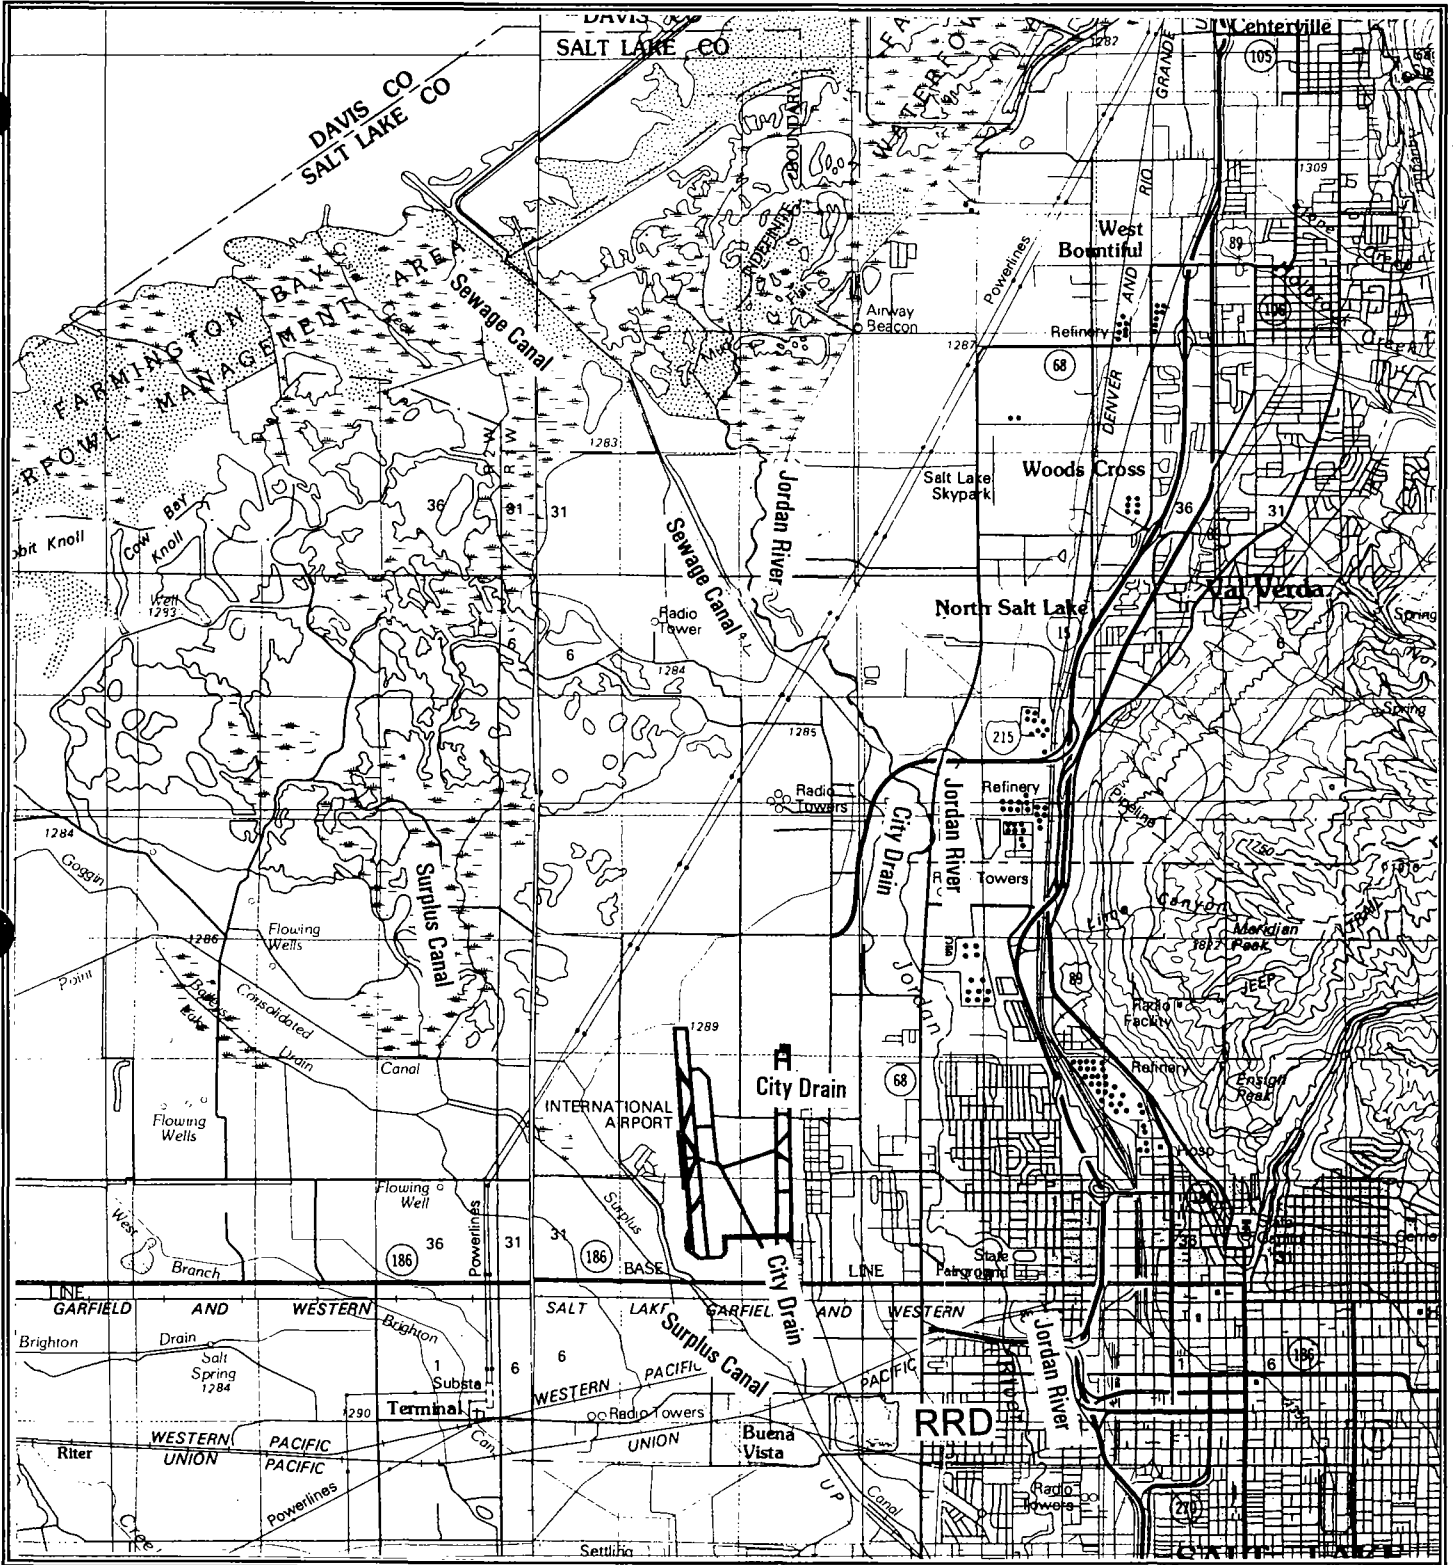
**SURFACE WATER BODIES - 15 Miles Downstream**

- City Drain
- Sewage Canal
- Surplus Canal
- Jordan River

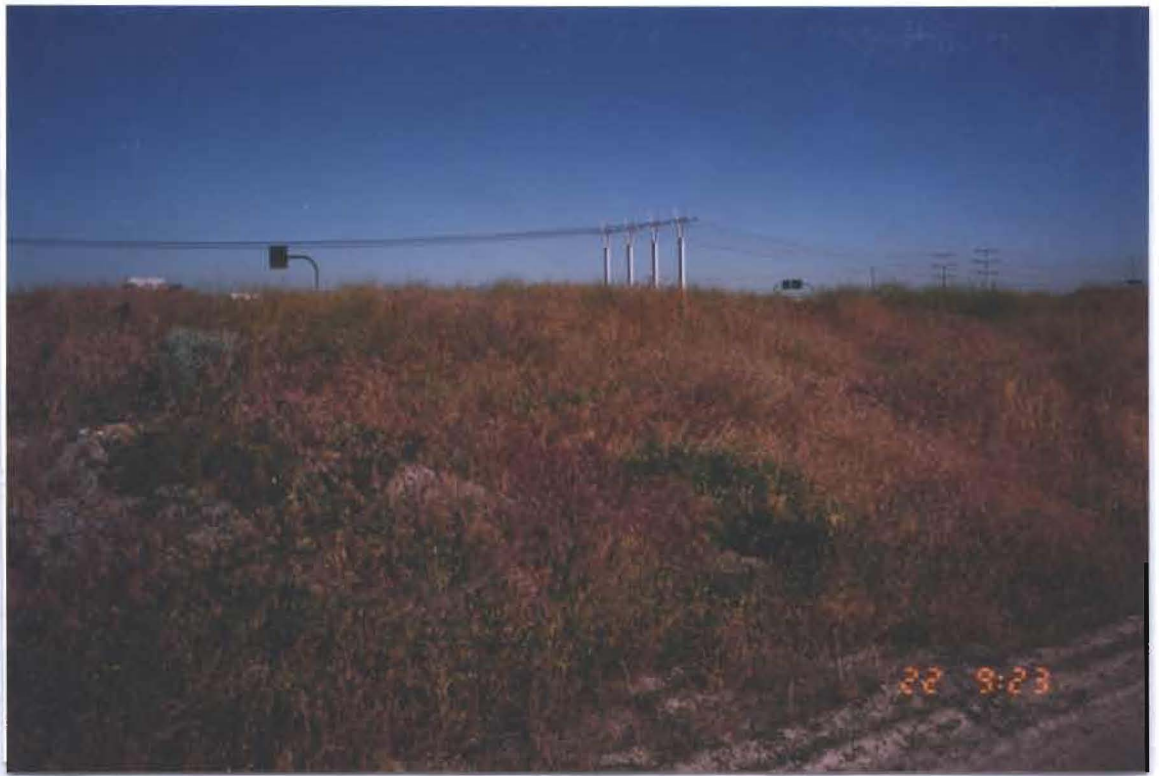
1. Approximate site of contaminated soil illegally dumped. Photo taken 6-22-95, looking Northwest. Photo 1 of 31.

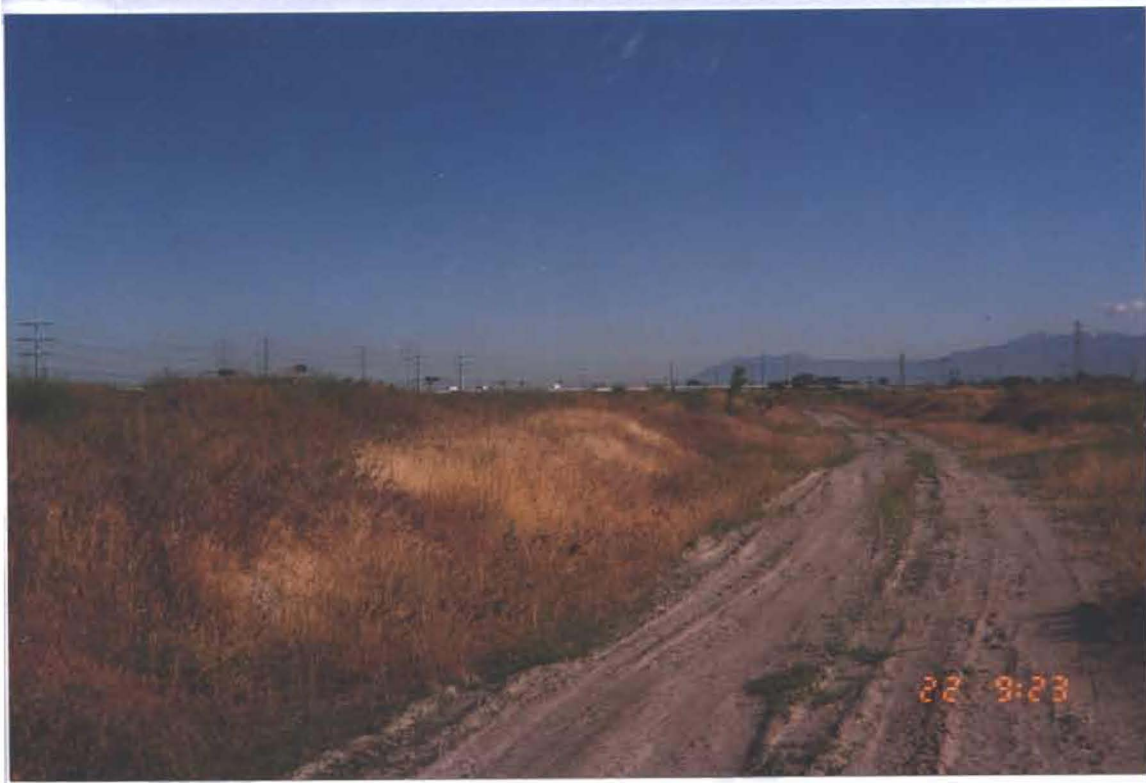
3. Site of contaminated soil illegally dumped. Notice whitened/stressed vegetation. Photo looks North. Photo 3 or 31.

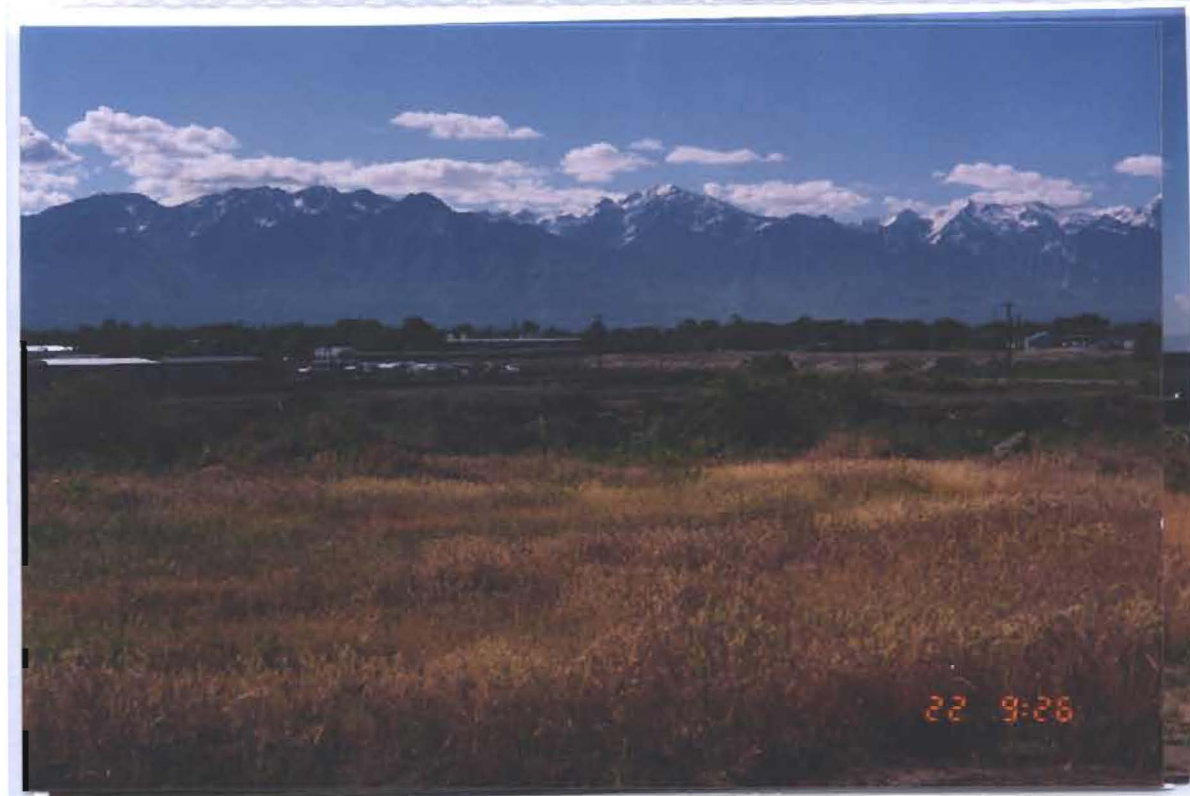
4. Southeast area of dump in middle ground. Plowed area currently used by Salt Lake City Corporation Parks & Recreation Dept., and Public Works. Photo looks Southeast. Photo's 4, 5, 6 of 31.

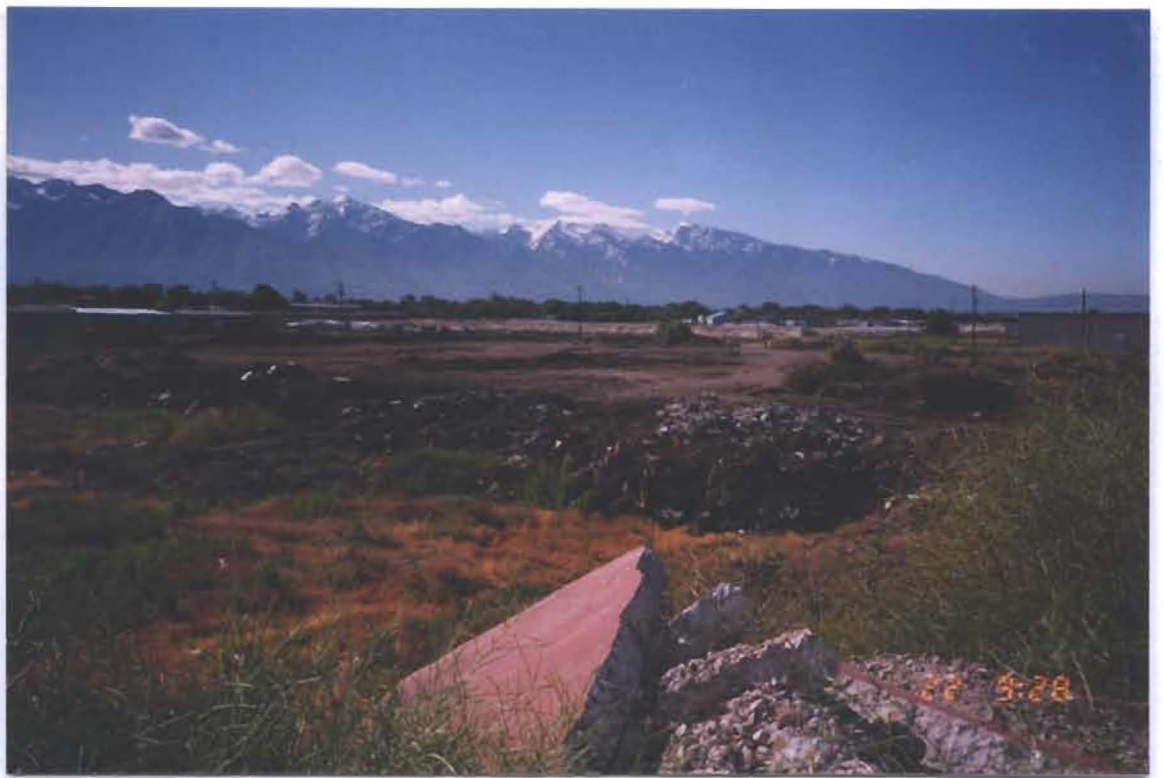
5. Southeastern, plowed area of dump currently used by SLCC Parks & Recreation for the disposal of grass & tree trimmings, yard clippings. View to the southeast. Photo 7 of 31.

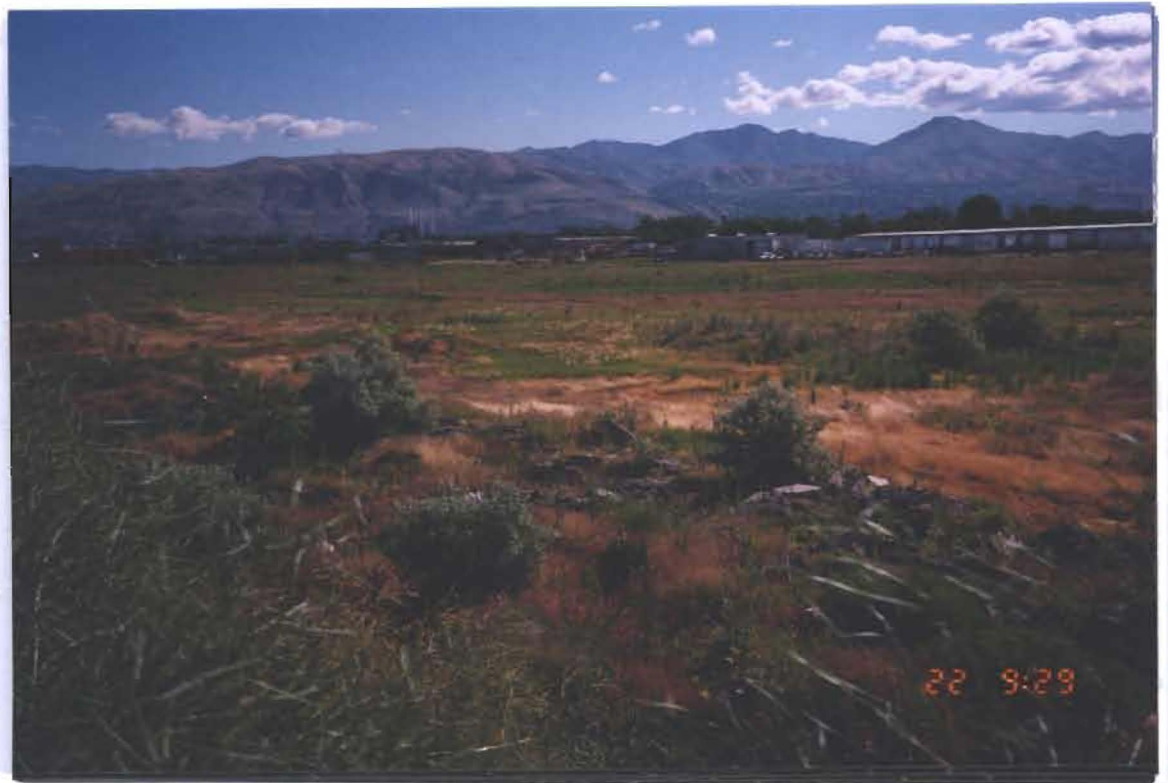
6. A 42" sewer pipe runs underground from north to south along the eastern edge of the landfill. Photo's 8-9-10-11 of 31.

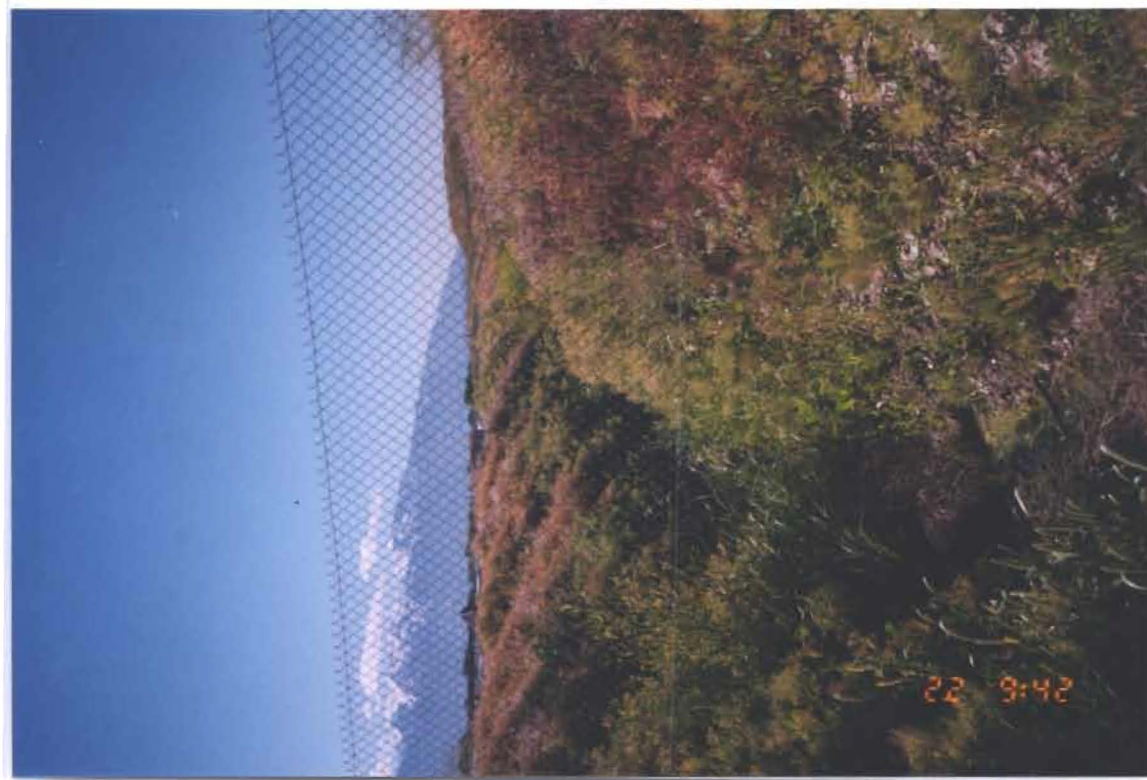
7. Photo of north unnamed ditch, where it exits the landfill at the northern fence. Note gap in fence and wetlands in the drain-ditch. Photo looks to south. Photo 12 of 31.

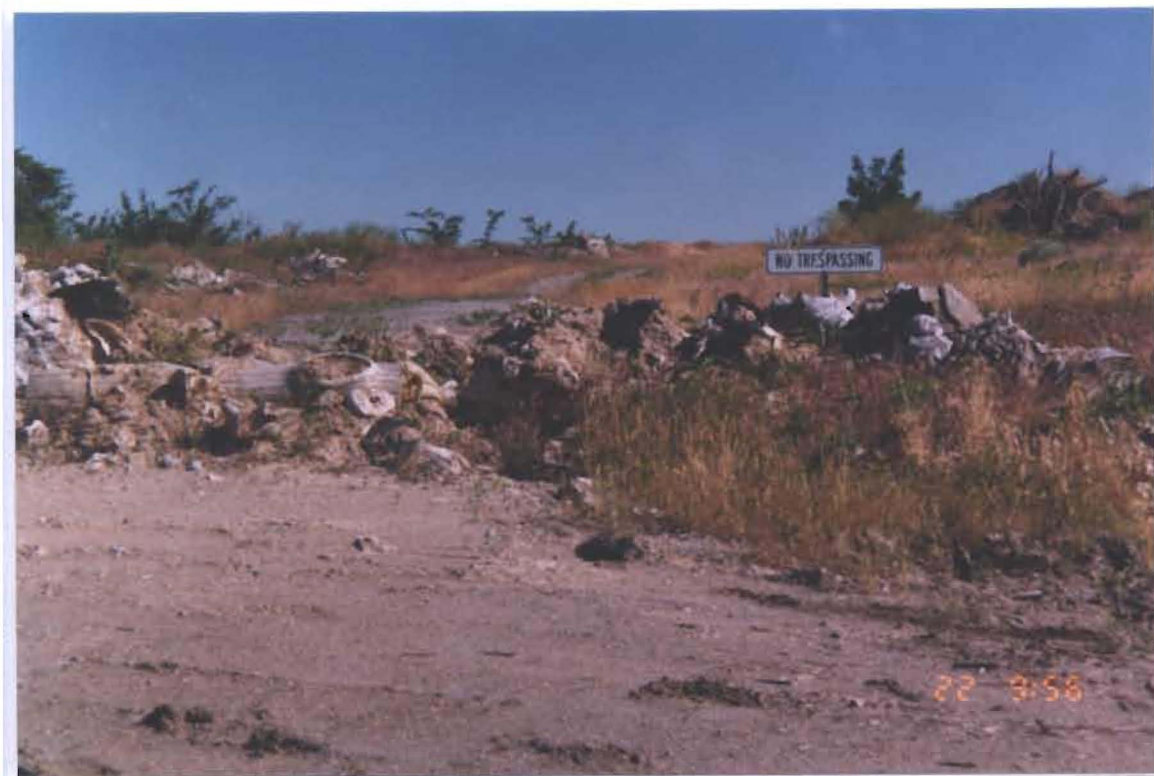
8. Photo looks to the north and was taken in the southern area of the dump. SLCC Parks & Recreation posted the sign and dug a trench across the road, filled it with debris, to prevent further trespass & illegal dumping. Photo 13 of 31.

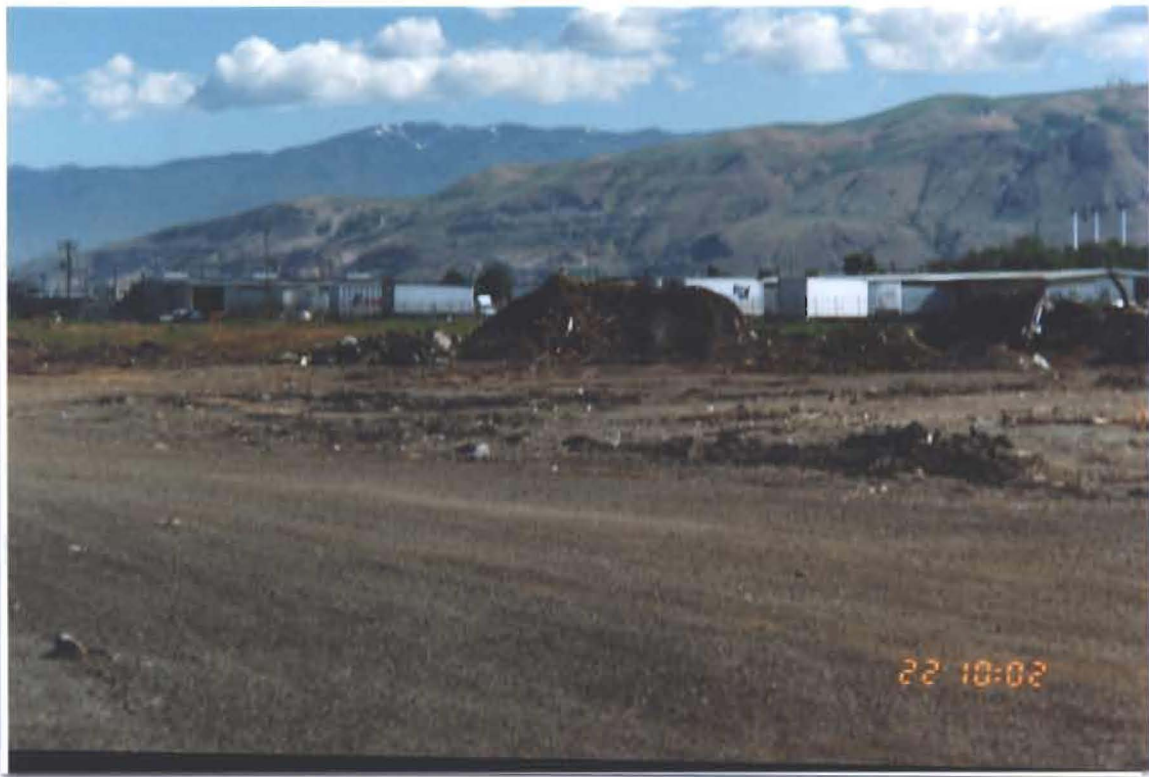
9. Southeastern area of the dump where SLCC Parks & Rec dumps yard clippings. Photo looks to northeast. Photo 14 of 31.

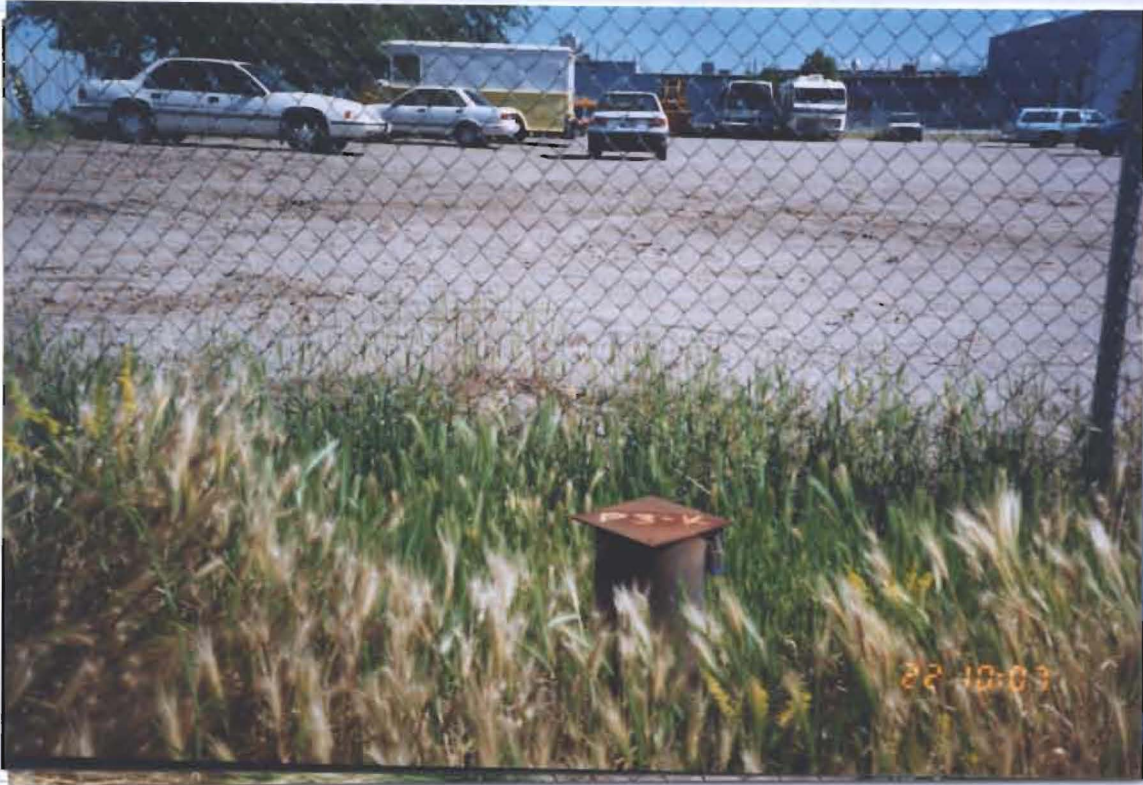
11. Portland Cement's monitoring well #P3-K, located to the east of the landfill on the north side of Indiana Avenue. Photo's 16 and 17 of 31.

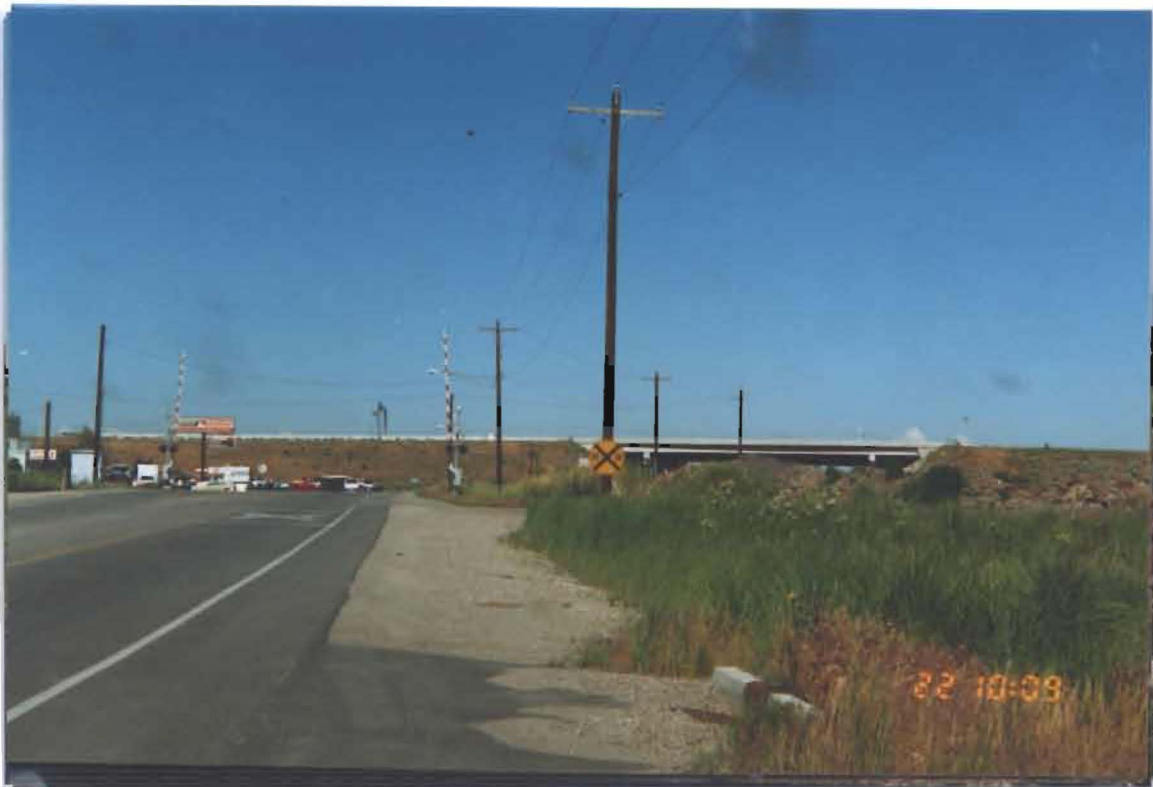
12. Panoramic view of dump from southeast corner, on Indiana Avenue. This area is unfenced. Photo's 18 through 22 of 31.

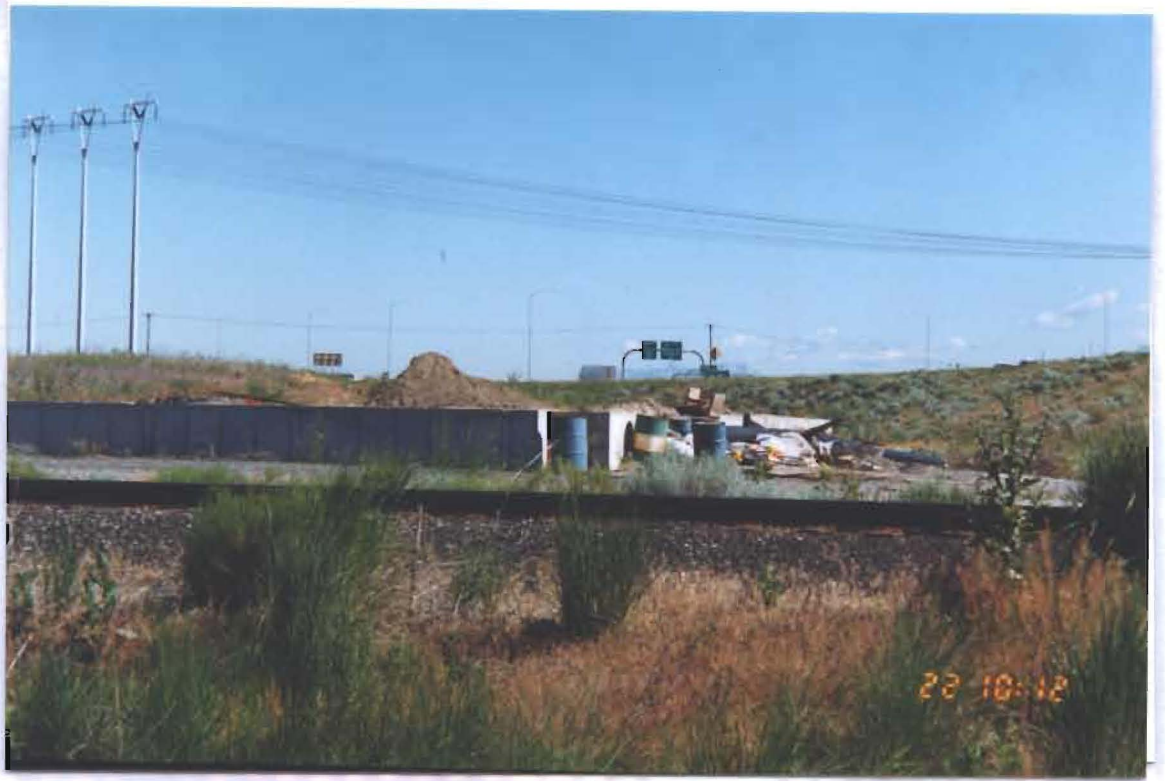
13. Photo looks north from Indiana Avenue onto the western refuse pile of RRD, west of City Drain and I-215. Note 5 drums, which were empty and removed by SLCC. Photo 23 of 31.

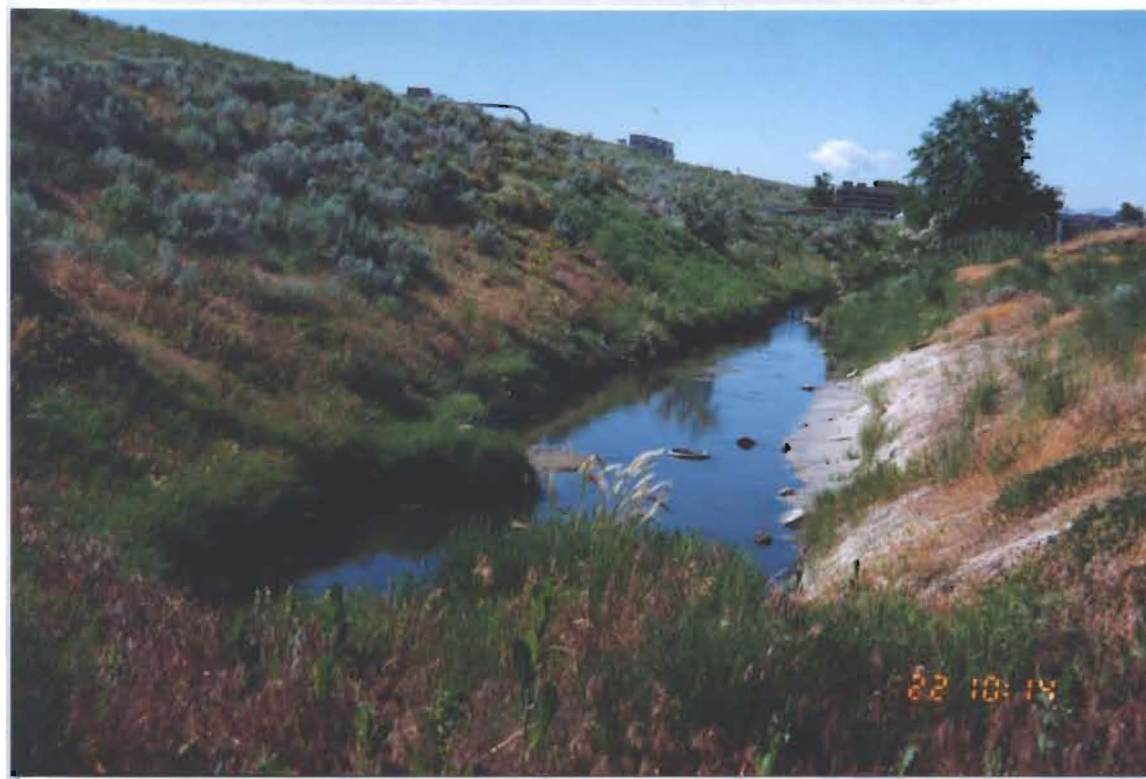
15. Photo looks south at City Drain canal, a wetlands area, on the south side of Indiana Avenue, across from the dump off-site and west of I-215. Drain goes under the road and then continues through the RRD site. Photo 25 of 31.

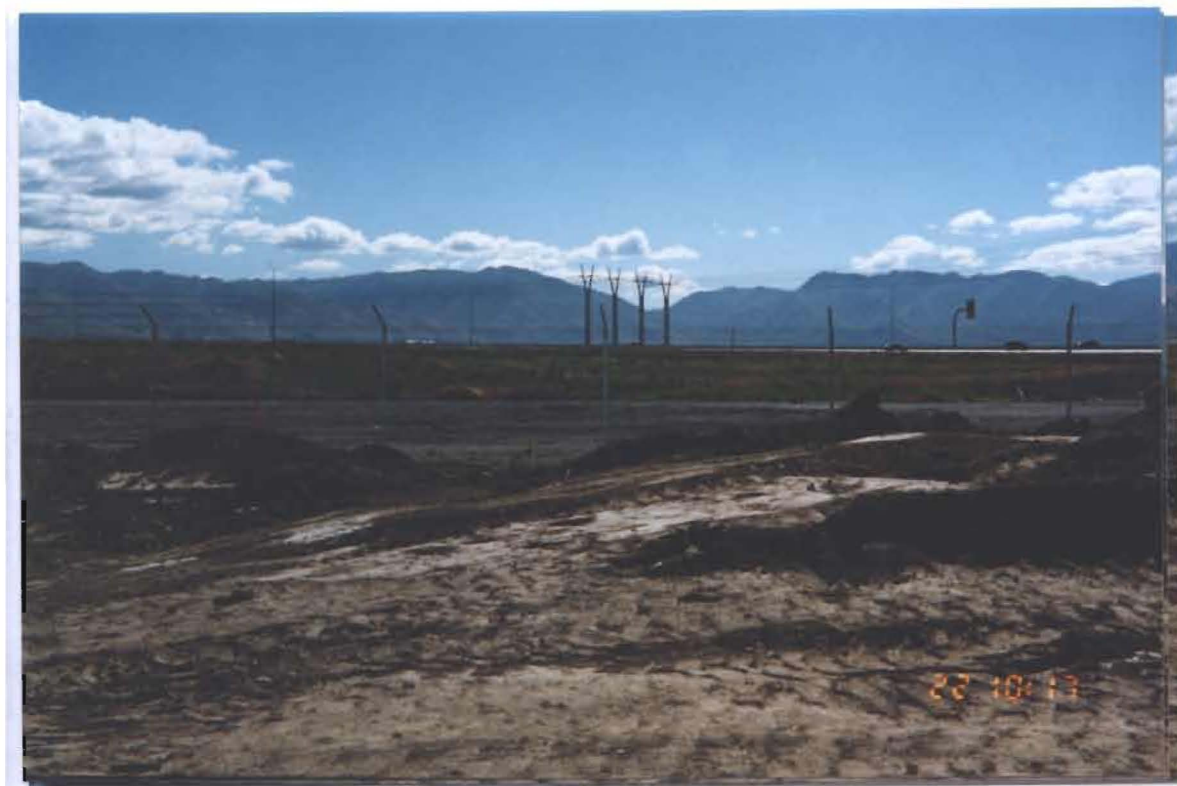
16. Photo taken from Chestnut Street, looking east-northeast, at western area of landfill, west of I-215. Landfill is past the fence, which has 3 strands of barbed wire on top. Photo's 26, 27, 28 of 31.

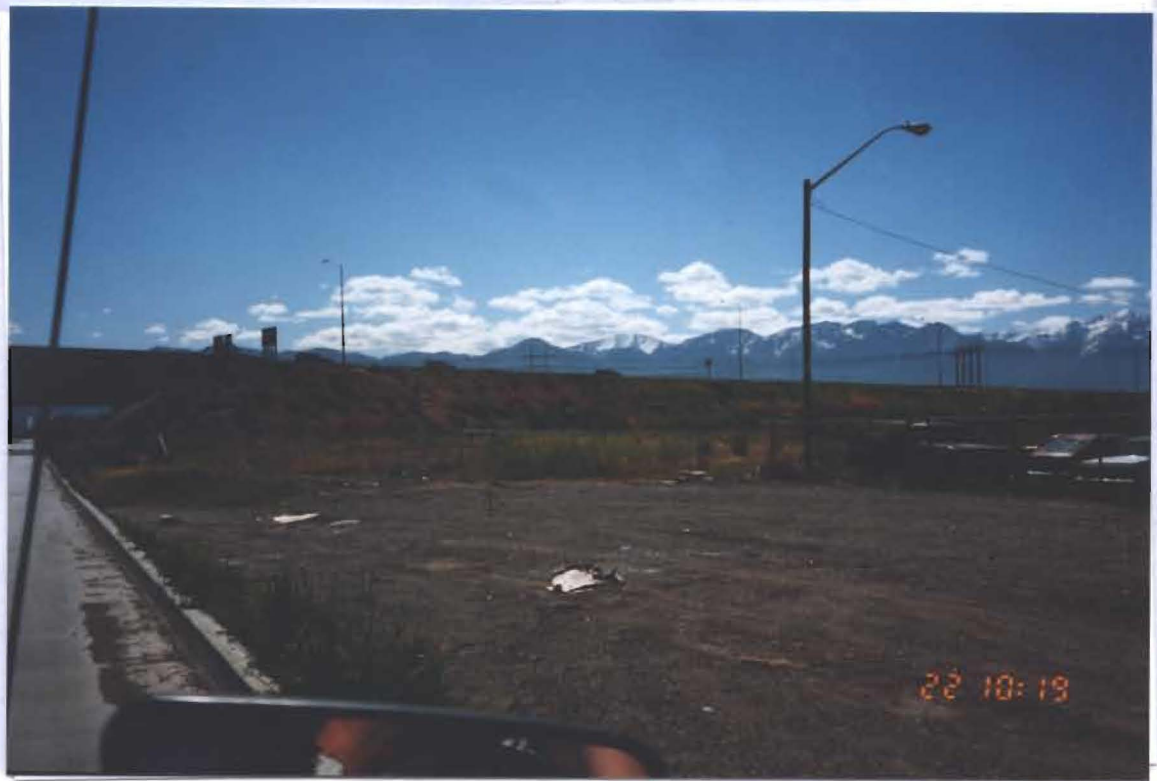
17. Photo taken looking east from northwest corner of RRD site. An observed release to the soil occurred in a barrow pit past the fence. The pit was an old bottle-collecting site before the fence was installed June of 1995. Photo 29 of 31.

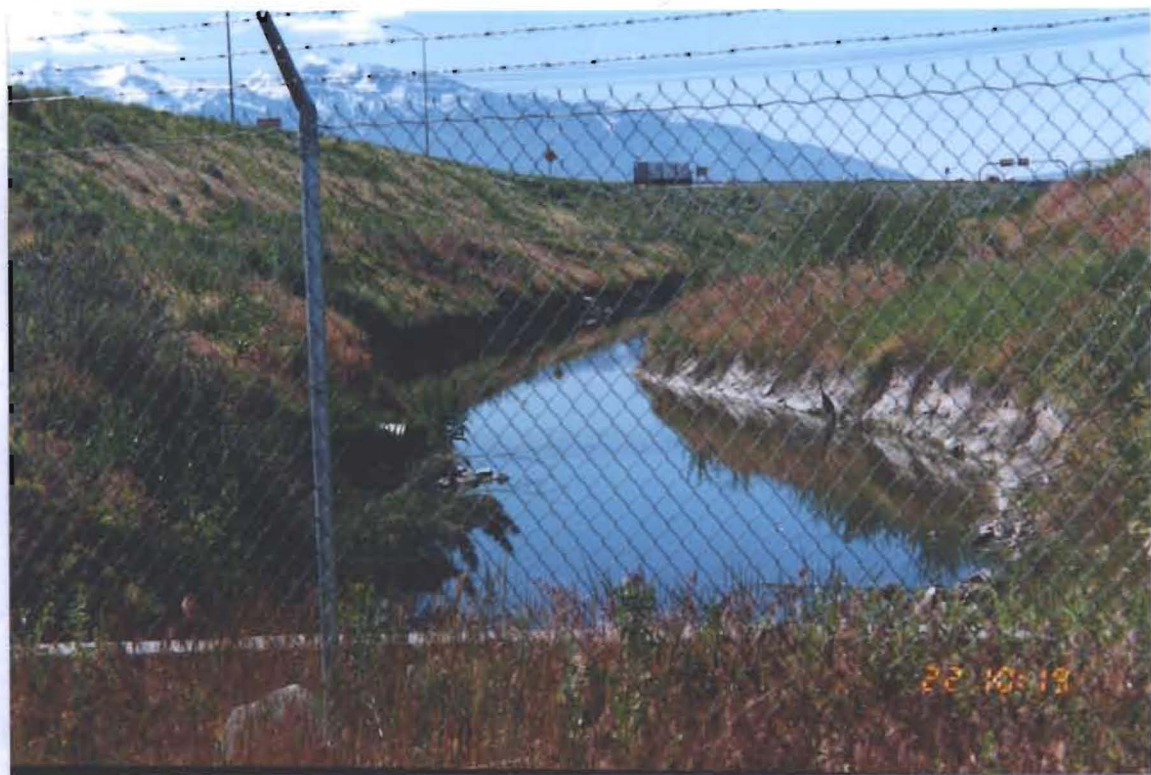
18. Photo looks south onto landfill and shows the City Drain. Note the crane on the west bank. Area is fenced. Photo 30 of 31.

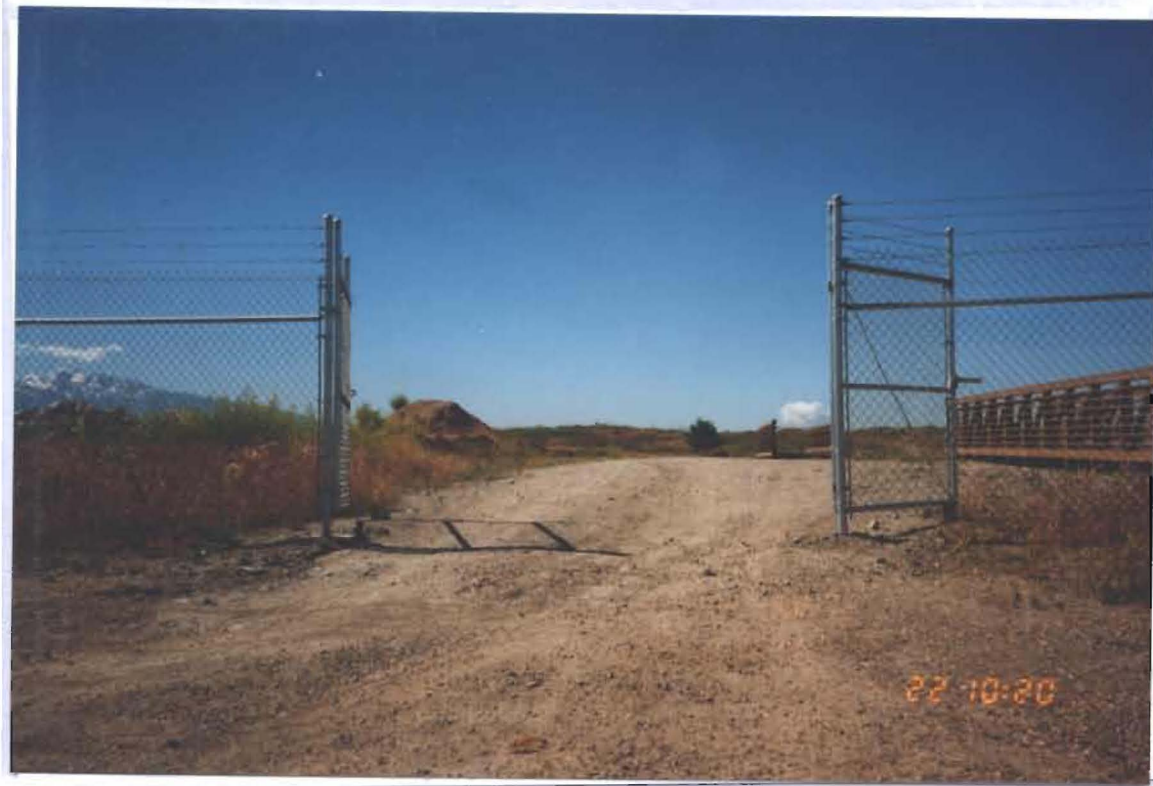
19. Photo looks south from 500 South street at the northern access to the RRD and its gate. A camera monitors access through this gate. Photo 31 of 31.
